PROJECT FINAL REPORT
Upper Caroline Brook Restoration Project
Project No. 15-03/319
2015-2017

Upper Caroline Brook Restoration Project

Project 15-03/319

B. Descriptive Project Summary

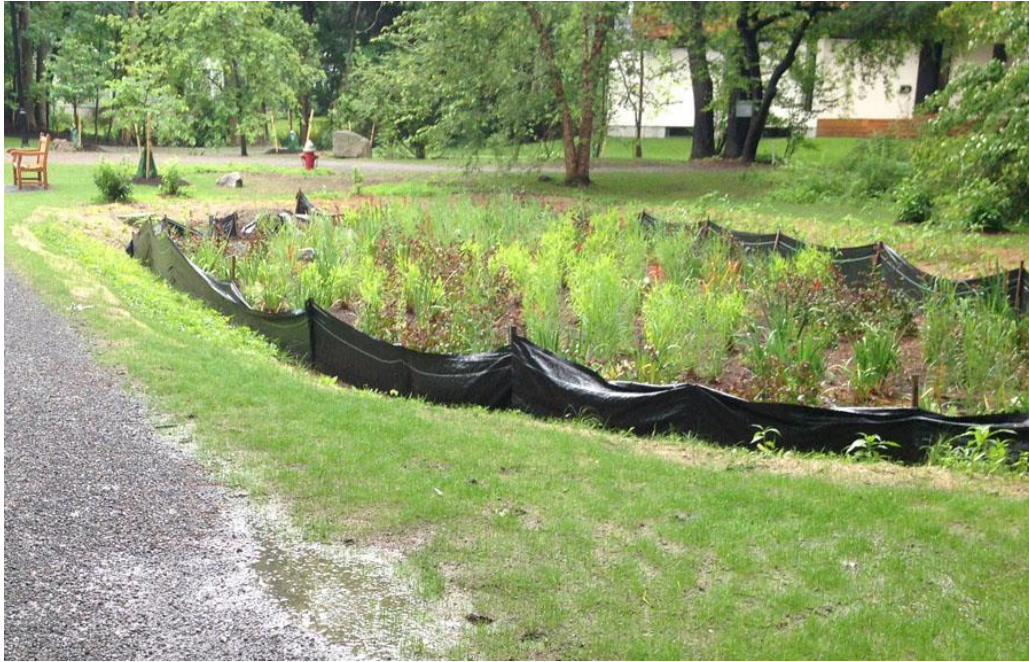
Bioretention Basin 1. Caroline Street

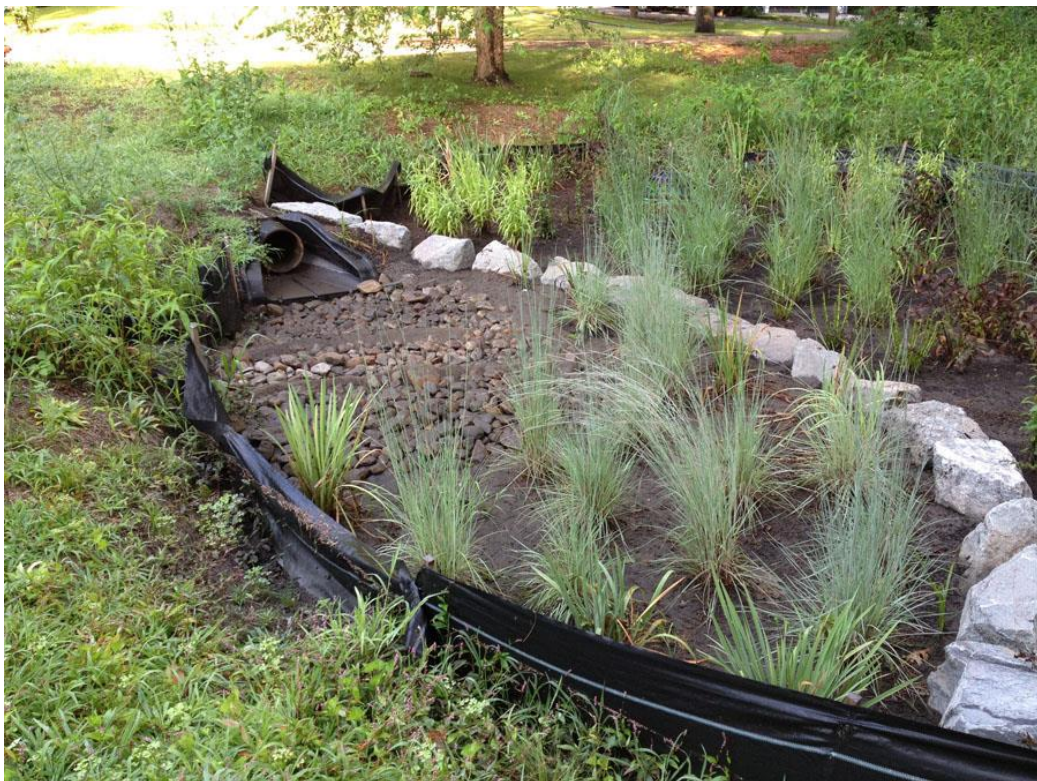
Bioretention Basin 1. Forebay

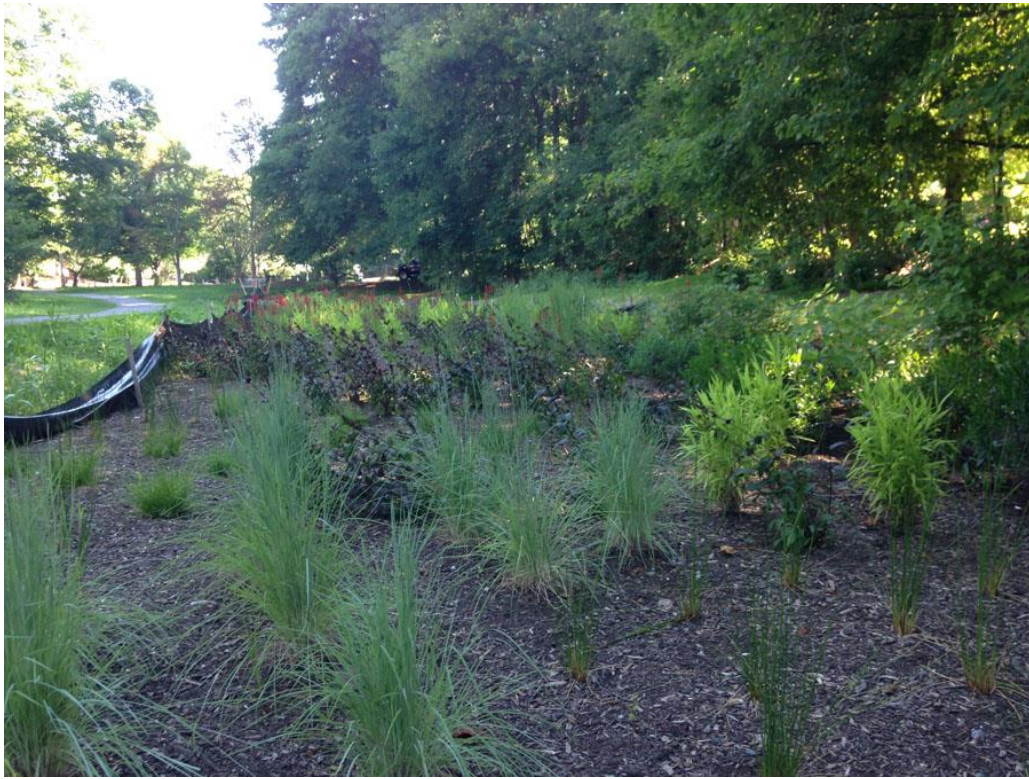
Bioretention Basin 2. Seaward and Abbott Streets

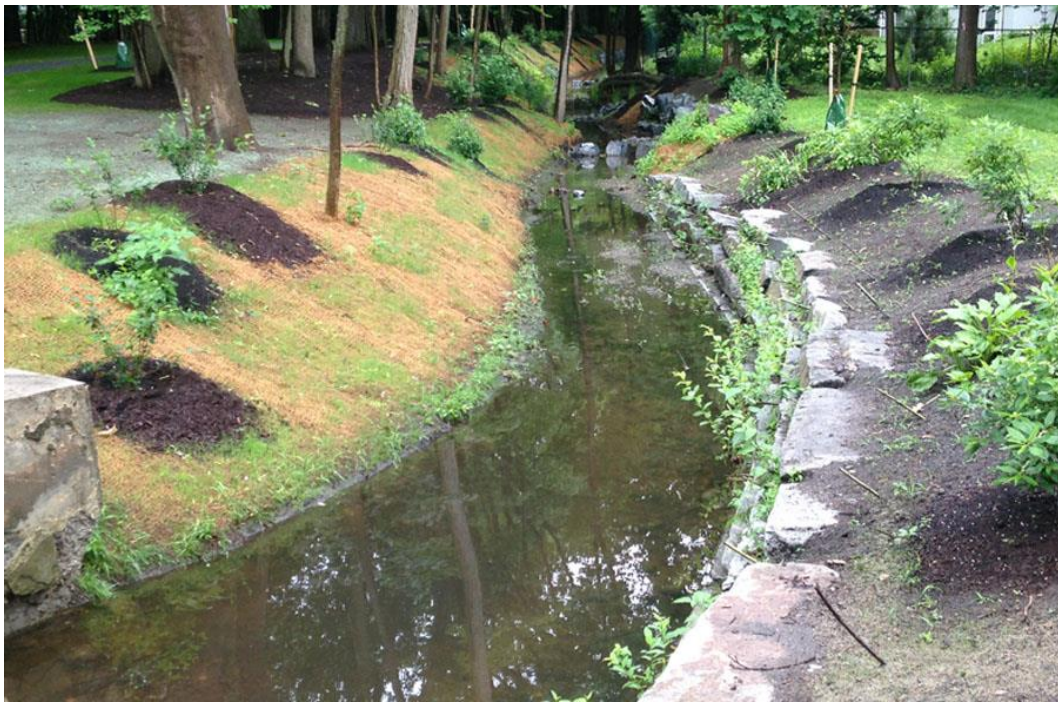
Stream Improvements. Upper Caroline Brook

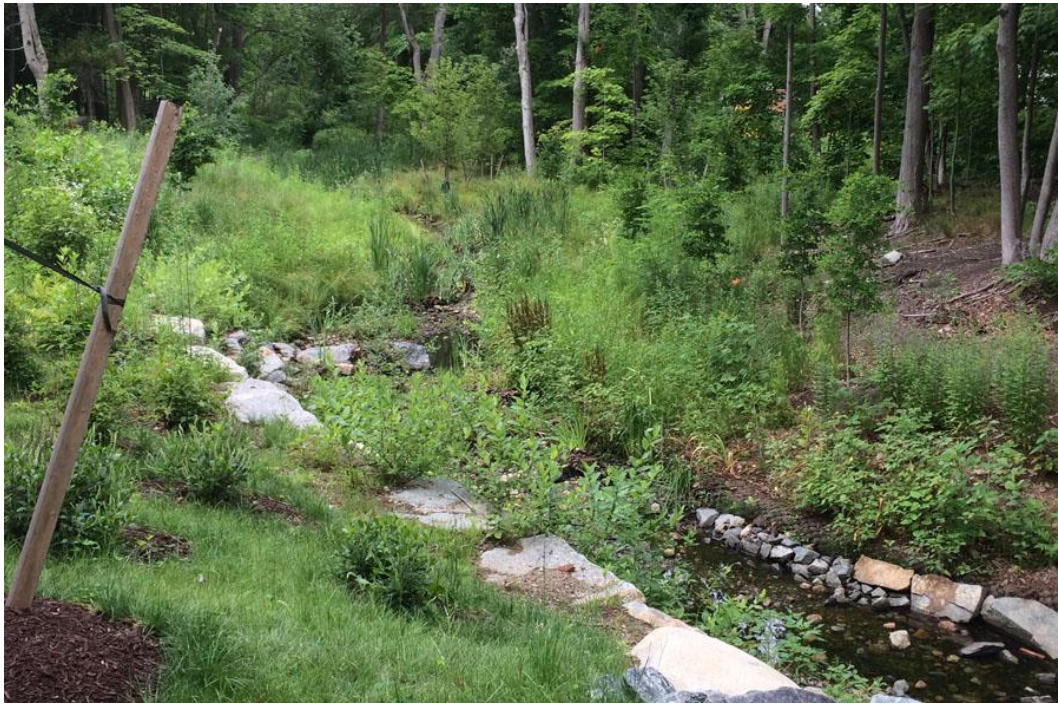
excess energy. A 290-foot section of Caroline Brook was relocated to stabilize and protect a sanitary sewer pipe which had been undercut and exposed by bank erosion.

Stream relocation area below Forest Street showing newly constructed stream channel.

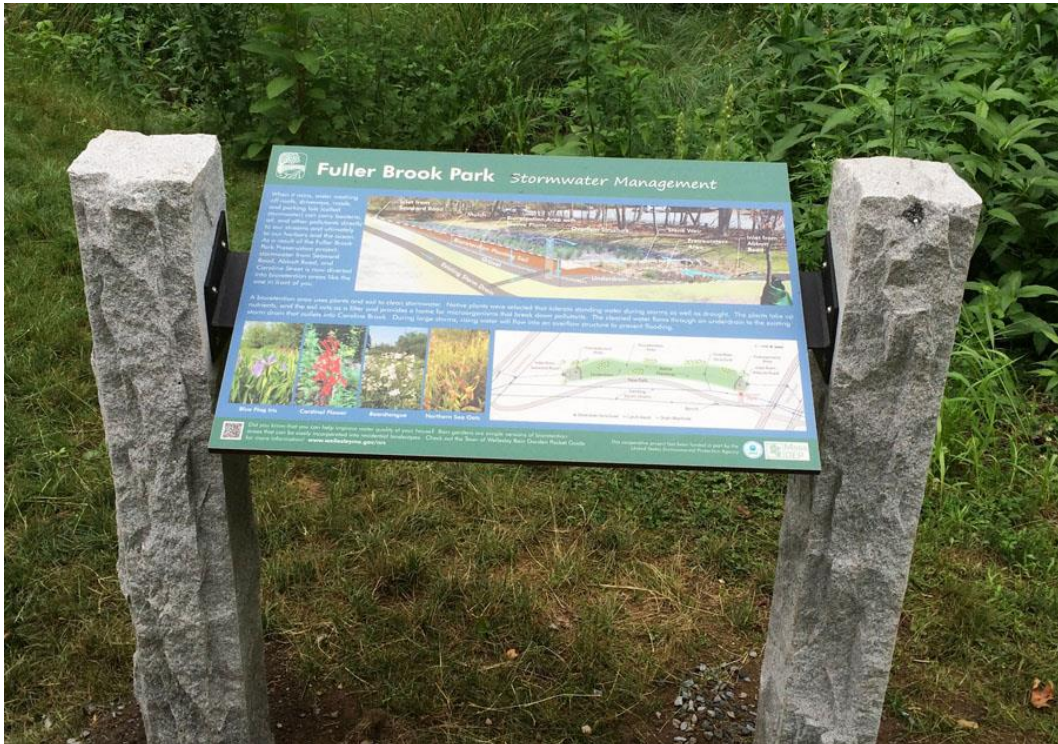
Interpretive sign at Abbott Street discussing stormwater management through bioretention.

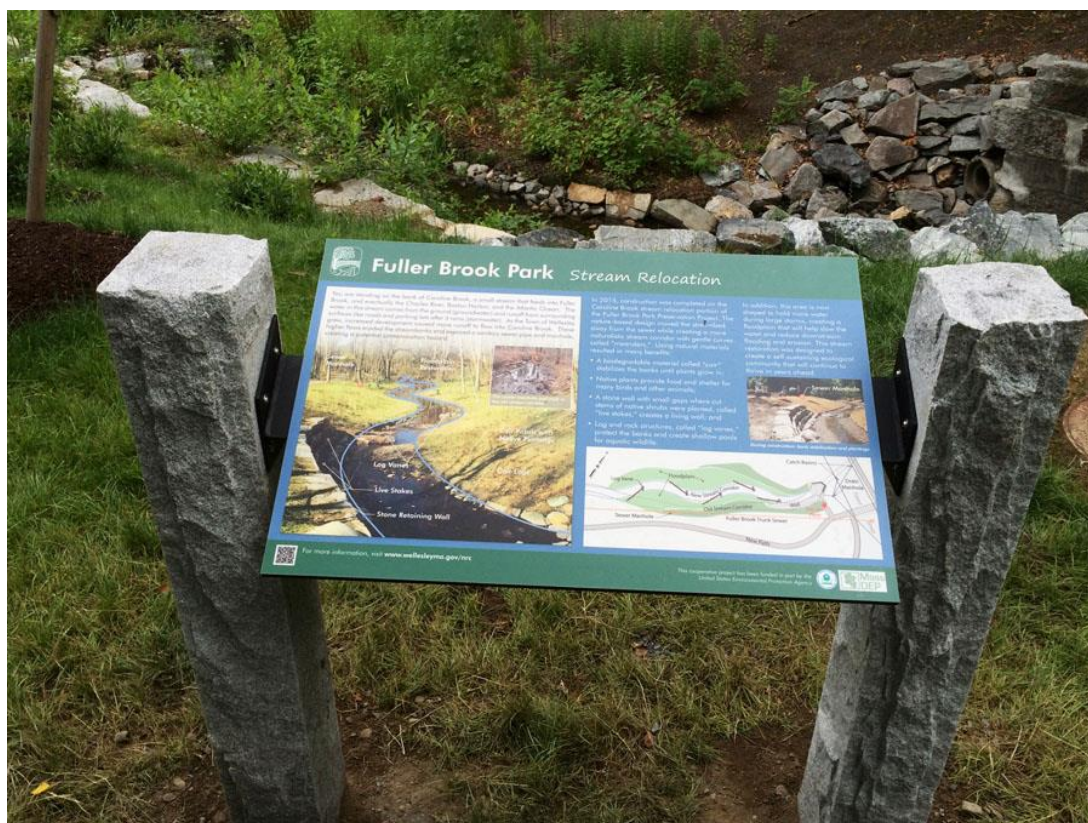
Interpretive sign at Forest Street discussing stream relocation to protect infrastructure and new stream channel and floodplain.
